PASSAIC RIVER BASIN
CANOE BROOK, ESSEX COUNTY
NEW JERSEY

CANOE BROOK RESERVOIR NO. 1 DAM

NJ 00525

**PHASE 1 INSPECTION REPORT
NATIONAL DAM SAFETY PROGRAM**

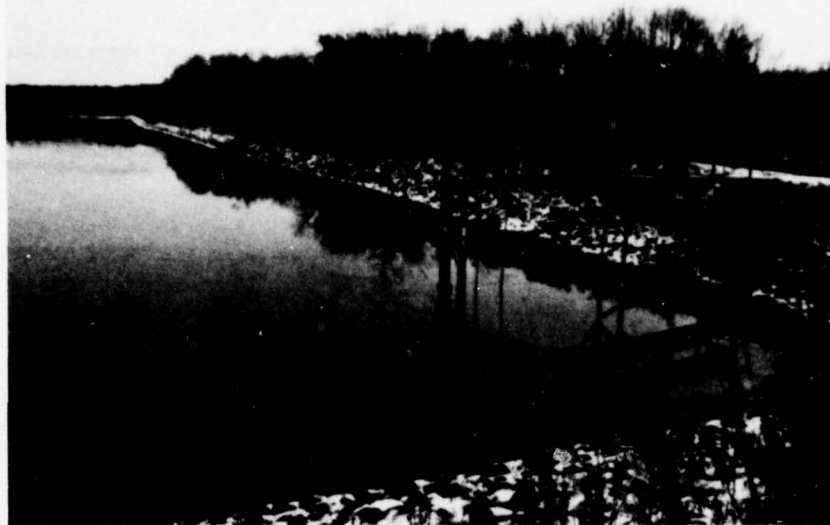
The dam was inspected for signs of settlement, seepage, erosion, cracking and any other evidence of undesirable behavior which might affect the stability of the structure. Several locations were observed where wave action has eroded and undermined the inboard slope of the embankment. Such conditions were particularly evident along the embankment sections bounding the south and

Photo 1 - Southern embankment looking east toward general area of wave erosion. (11-29-78)

Irregularities and eroded surfaces on the crest and slopes should be repaired as soon as possible.

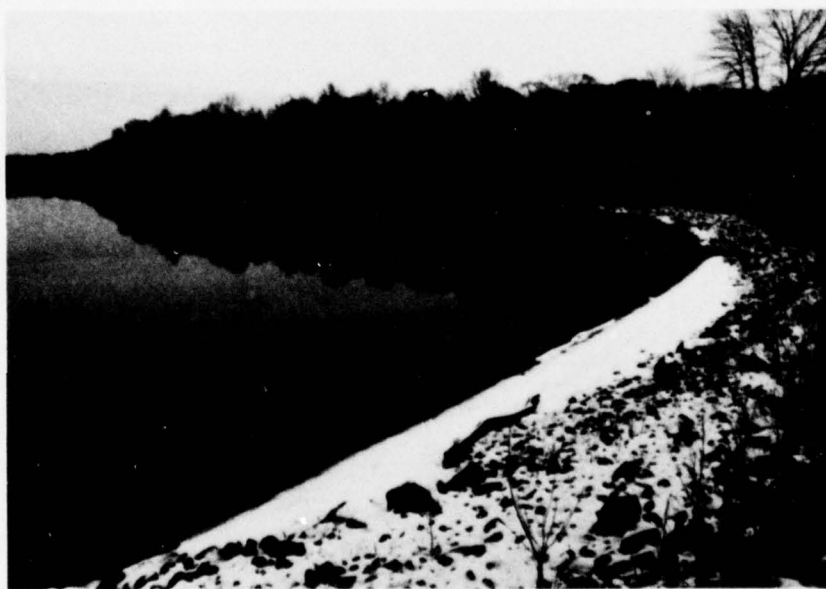
Photo 2 - Southeastern shoreline, showing area of wave erosion. (11-29-78)

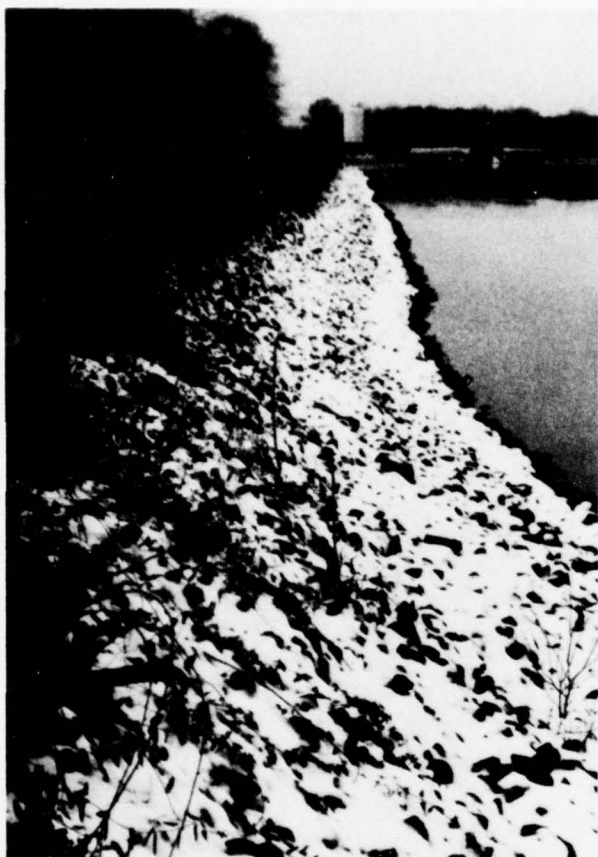
Photo 3 - Wave-cut
southern embankment
looking west.
(11-29-78)

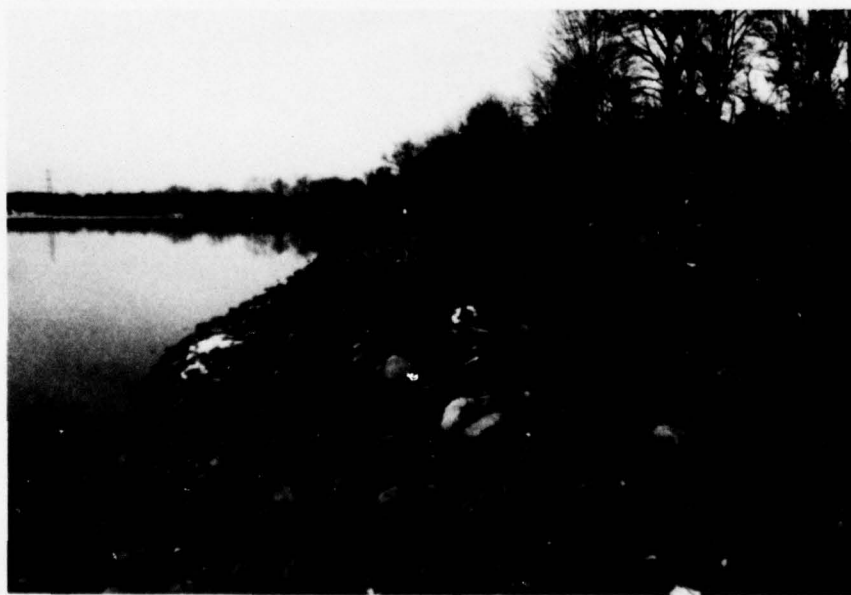
Several locations were also noted where troughs in the embankment have been eroded by foot traffic of persons gaining access to the reservoir for fishing. At some locations riprap has been dislodged from the inboard slope (Photo 4). These troughs act as channels for rain water runoff, and with time could substantially reduce the effective embankment cross section (Photo 5). Other troughs were observed in portions of the embankment crest, and were reported to be caused by trucks used for remedial work (Photos 6 and 7). In some areas the wheel loads from the trucks have caused depressions in the crest up to two feet deep and have deformed the crest of the dam severely. Many of the troughs were filled with water at the time of the inspection.

Photo 4 - Riprap on north shoreline dislodged by
fishermen. (11-29-78)

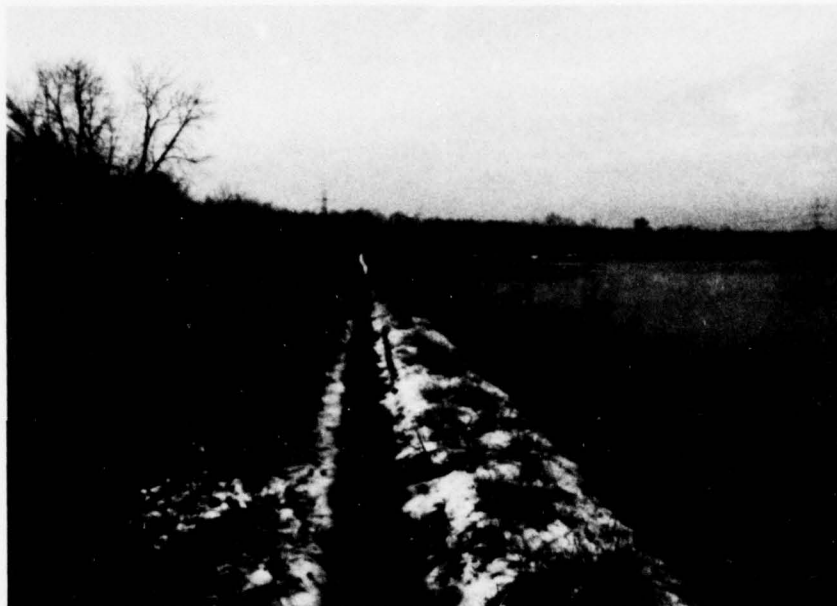
In some places along the top of the reservoir embankment, there are deep ruts caused by trucks driving along the embankment top. These ruts result in a narrower and possibly lower embankment crest in some areas.

Photo 7 - Vehicle tracks on west embankment crest.
(11-29-78)

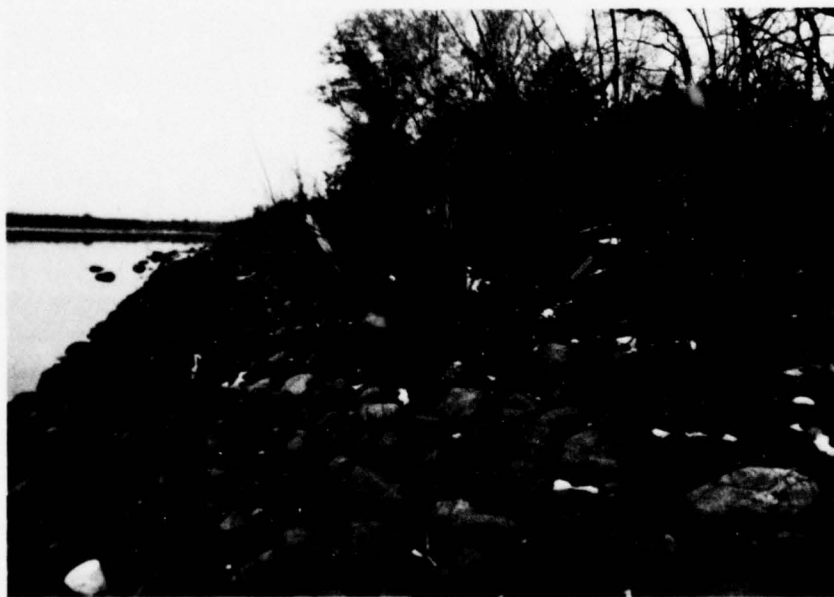
Very thick and sometimes deeply rooted vegetation and small trees were observed almost everywhere on the embankment, including the inboard slope and crest (Photo 8). There is currently no regular maintenance program for removal of this vegetation other than a "mowing" project which reportedly takes place at five-year intervals.

Photo 8 - Tree stumps and new growth vegetation on
east embankment. (11-29-78)

<u>VISUAL EXAMINATION OF</u>	<u>OBSERVATIONS</u>	<u>REMARKS OR RECOMMENDATIONS</u>
VEGETATION	Heavy vegetation including small trees, bushes and ground cover observed throughout entire length of embankment.	All trees and brush should be removed and periodically cut.
JUNCTION OF EMBANKMENT AND ABUTMENT, SPILLWAY AND DAM	Not Applicable.	
ANY NOTICEABLE SEEPAGE	None observed.	
STAFF GAGE AND RECORDER	Slab staff gage observed.	Owner maintains daily records of reservoir level.
DRAINS	No embankment drains.

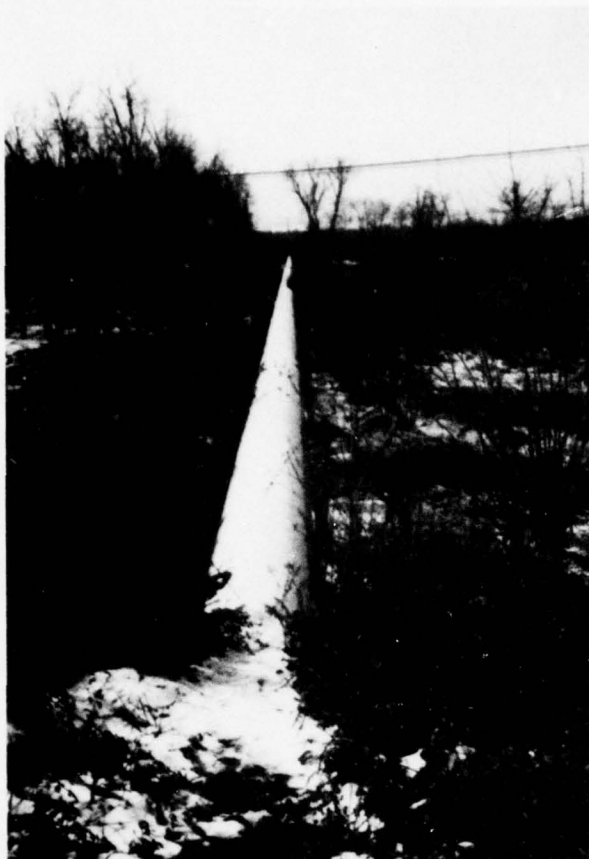
Photo 9 - 48-inch
transfer pipeline
to Canoe Brook
Reservoir No. 2.
(11-29-78)
